## 14.0 Rifle, Colorado, Disposal Site

### 14.1 Compliance Summary

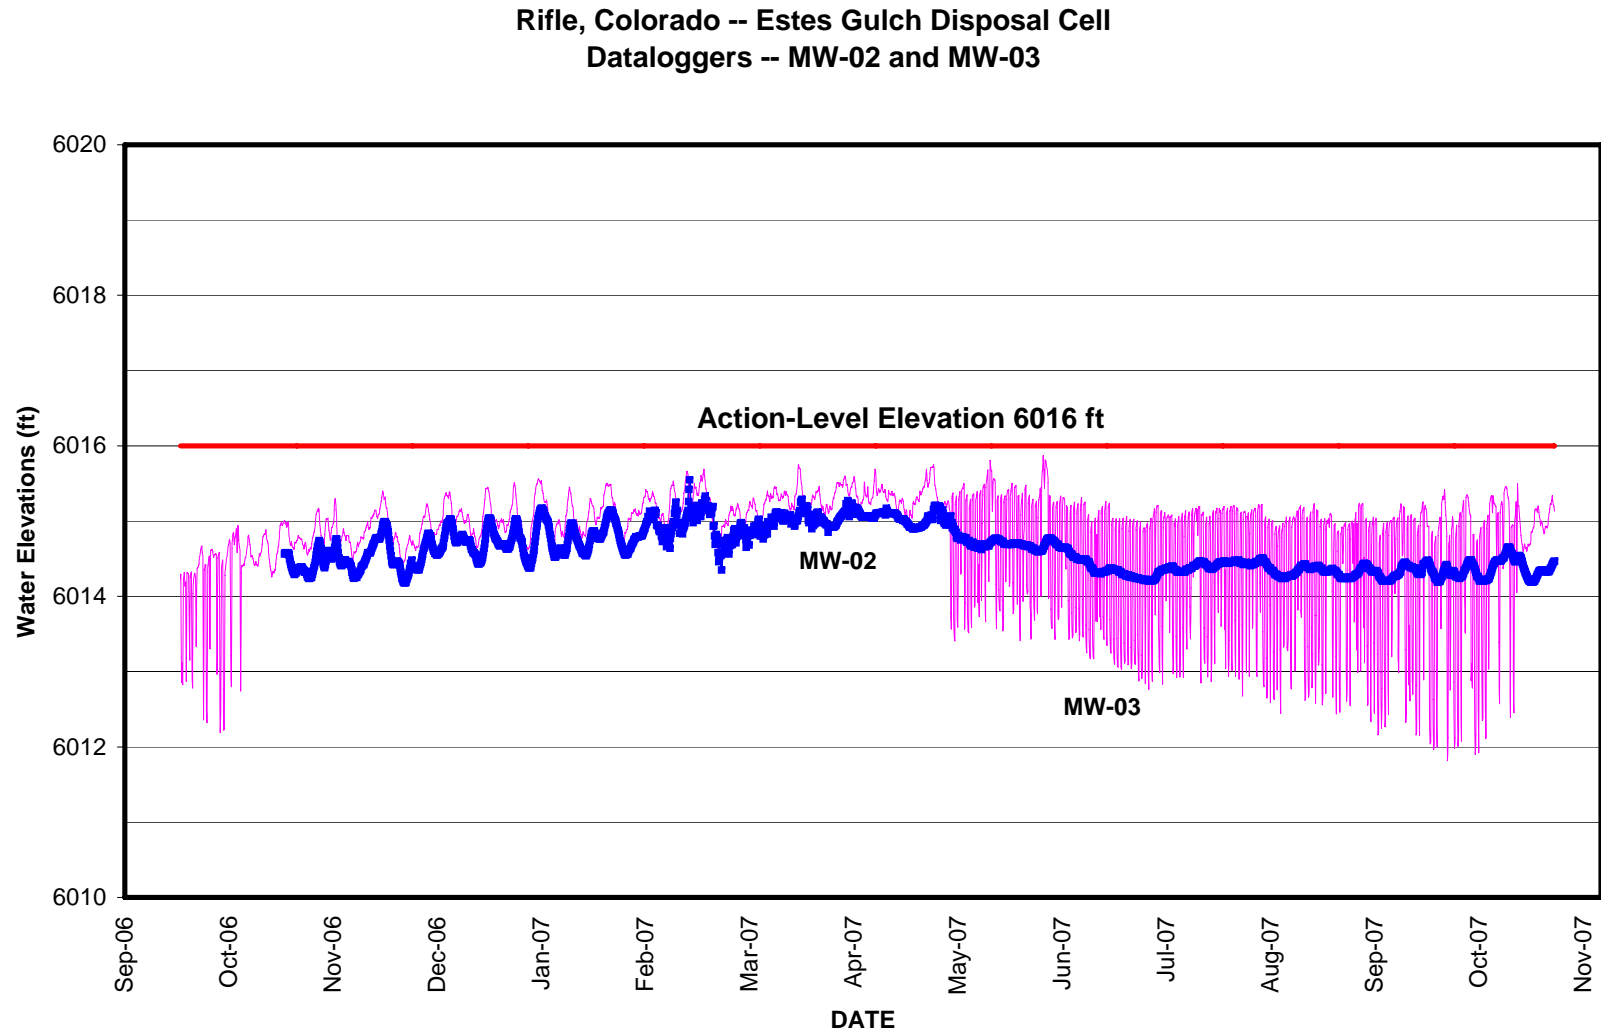
Figure 14–2. Disposal Cell Pore Water Levels in Standpipes MW–02 and MW–03 at the Rifle, Colorado, Disposal Site.

Over the course of the year, datalogger information indicates that the water level in MW-03 increased from 6,013 ft to approximately 6,014.5 ft within several days of the shutoff in November 2006 and slowly approached the 6,015.5 ft level over the winter, but never reached the compliance level or 6016 feet (Figure 14-2). Well MW-02 slowly increased from approximately the same level (6014.5 ft) to about 6015 over the winter. As soon as pumping resumed in spring 2007, the water level in MW-02 decreased to about 6014.5 over the summer and fall. Water in MW-03 decreased to about 6015 feet during the same period. When pumps were turned off in late October water levels again began to slowly rise. About 200,000 gallons of water were produced during the 2007 season.

To date, approximately 4.2 million gallons of water have been pumped from the disposal cell. This includes the volume pumped during construction of the disposal cell and the volume pumped since dewatering was initiated again in 2001. The recovery of the water levels in the standpipes to approximately 6,015 feet after pumping is discontinued, and even slower recovery afterward toward the 6,016-foot action level over the next six months, suggests a large reservoir of water remaining in the disposal cell.

DOE intends to remove enough water from the disposal cell to lower water levels in the standpipes to below the 6,014-foot elevation. At that time, pumping will be stopped, and water levels will be monitored to ensure they remain at or below that elevation. If water levels again rise, pumping will resume.

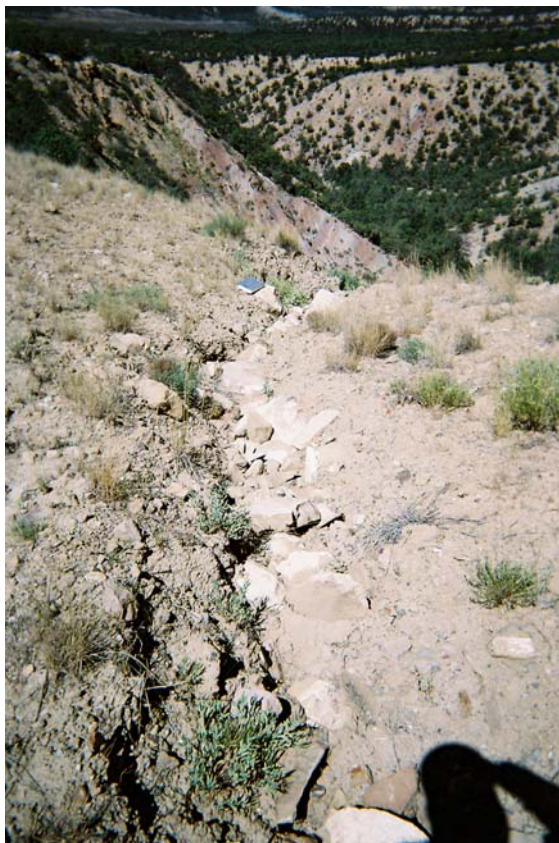
A revegetated interceptor trench was constructed at the top of the disposal cell to protect the cell from storm-water and snowmelt run-on. The trench diverts water to the arroyo west of the site. Significant erosion occurred during a major rain event in 2005 and repairs to the interceptor trench were performed. Rocks were moved into the eroded channel and the erosion was stabilized. The area had no new erosion at the time of the 2007 inspection (PL-1). Monitoring of this trench will continue.

*RFD 9/2007. PL-1. Erosion mitigation at the top interceptor trench (no new erosion).*

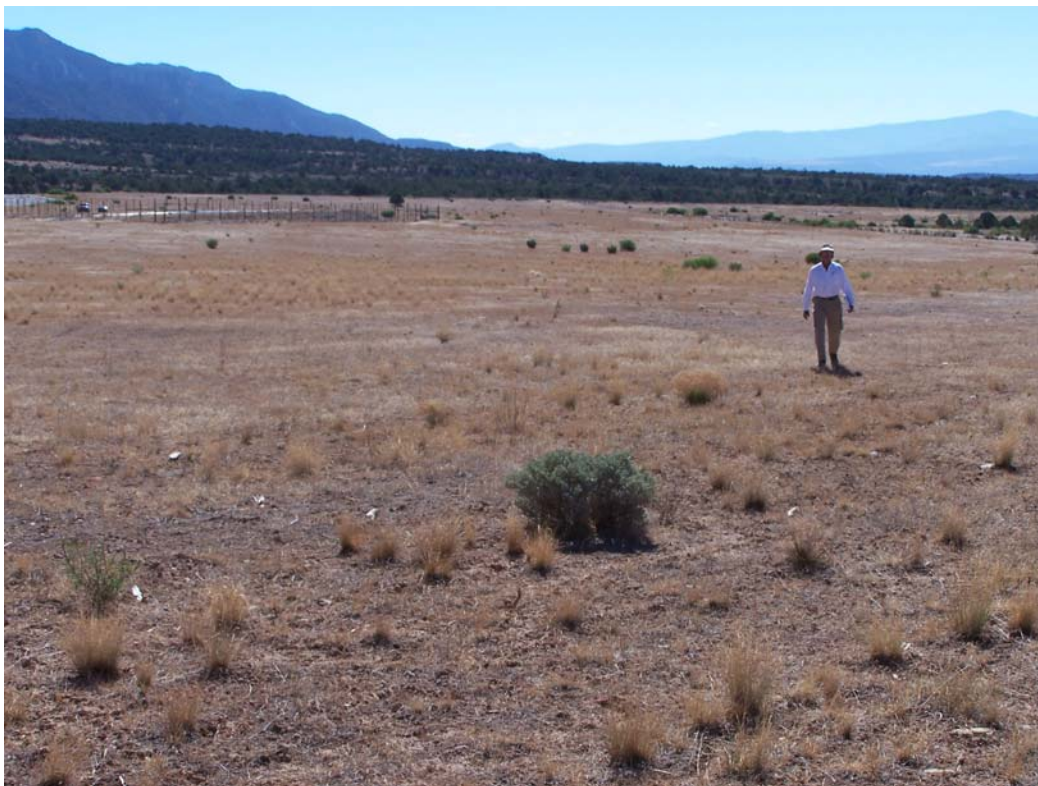
**Onsite Reclaimed Areas**—Disturbed areas around the edges and south of the disposal cell were reseeded in 1996. The vegetation, primarily grasses, continues to be stressed due to several years of local drought conditions. No evidence of cattle grazing within the site boundaries during the past year was observed. There were no noxious weeds found on the site during the inspection.

*RFD 9/2007. PL-2. View of dry revegetated rangeland inside site boundary.*

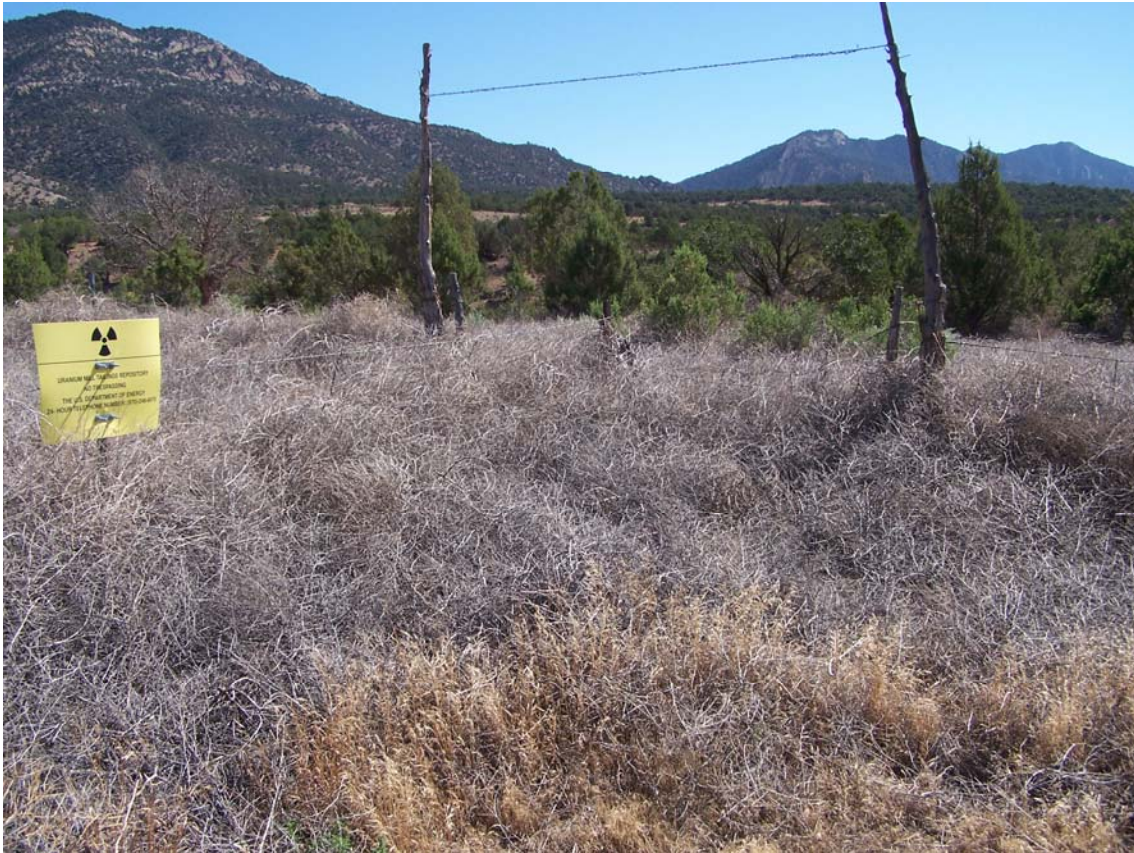
**Outlying Area**—The area beyond the site for a distance of 0.25 mile was visually inspected for signs of erosion, development, or other disturbance. The primary land use in the area is grazing and wildlife habitat. No activity or development was observed that might affect site integrity or the long-term performance of the disposal cell. The revegetated grasslands south of the cell were especially dry this year (PL-2). Tumbleweeds that accumulated along the southeast portion of the perimeter fence (PL-3) were removed in September 2007.

*RFD 9/2007. PL-3. View of tumbleweeds at personnel gate along southeast side of perimeter fence.*

In 2007, DOE removed tumbleweeds from the perimeter fence and repaired broken stands of the barbed-wire fences on site.

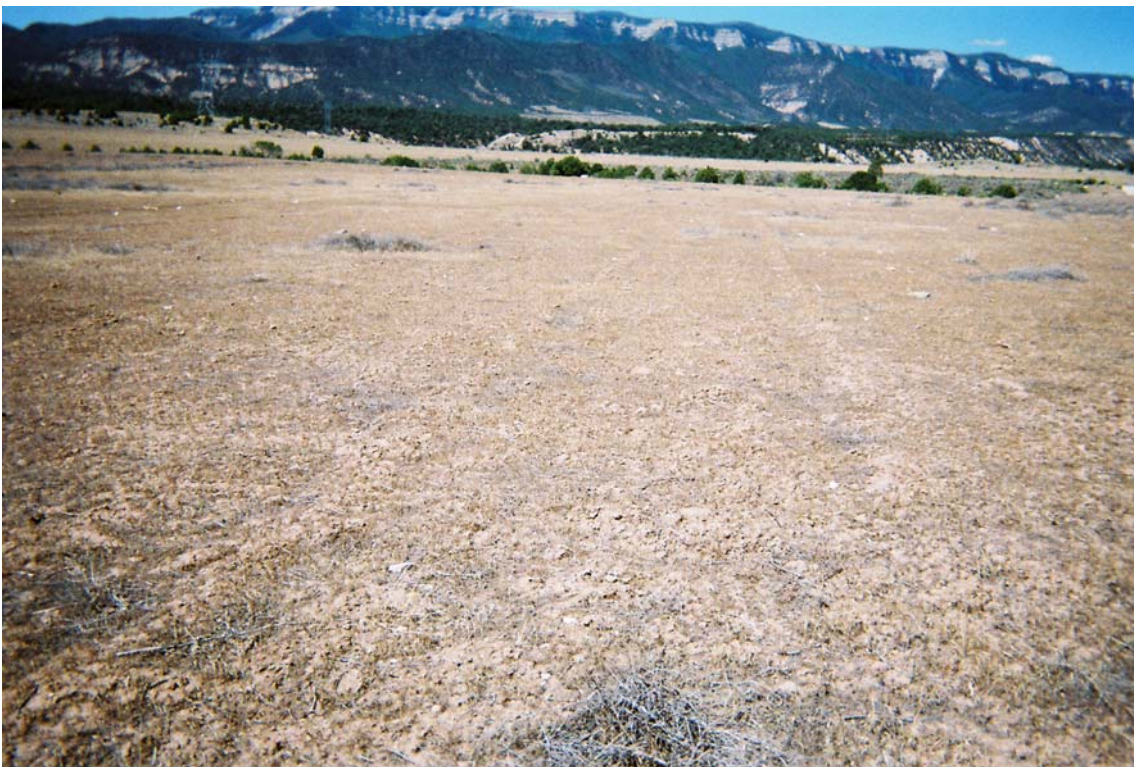
The revegetated area directly south of the disposal cell on BLM-managed land was inspected. During construction of the cell, DOE was granted a Right-of-Way Reservation Permit by the BLM to use this area for topsoil storage and other purposes. Because this area did not successfully revegetate, it was reseeded in 2000 and again in 2005. At the time of the inspection, annual weeds dominated plant cover throughout the 16-acre area. It was anticipated that the annual weed cover would provide shade and allow desirable perennial species to take hold during the next several years. Unfortunately, 2007 has been a dry year and cover has decreased from 2006 (PL-4). No corrective action is recommended at this time. Inspectors will continue to monitor the revegetated area.

*RFD 9/2007. PL-4. View to west of dry, 16-acre BLM rangeland that was reseeded in 2005.*
